Manhole Inspection Summary

Manhole # S51AA_008MH

Insp Date: **3/4/08 8:04 AM**

Location Address: **Ellwood- Decker**

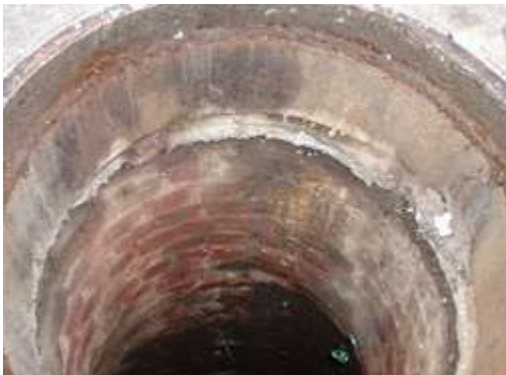
Defect 2

Frame Offset: **0.5** (in.) Condition: ☐ Sound ☐ Cracked ☒ **Leaks**

Frame Leaks

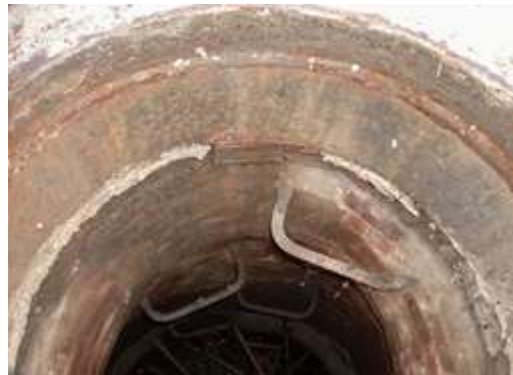
Defect 1

Infiltration: ☐ None ☐ Joint ☐ Cracks ☒ **Mortar** ☐ Roots ☒ **Wall**

Adjustment Joint

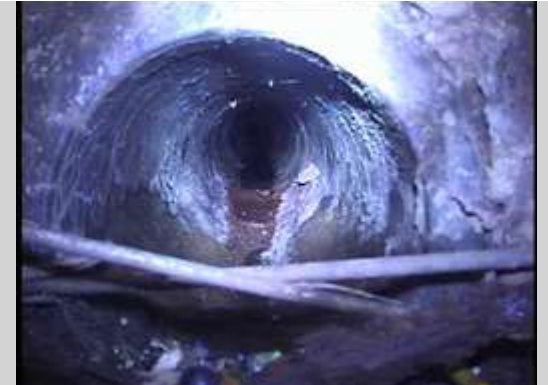
12 O'Clock Outflow

8 in. Circular Gravity Sewer
Pipe Out @ 12 O'Clock

Infiltration: **None** Pipe Seal Cond: **Sound**
